ecology and environment. inc.

Date: April 22, 1994

Subj: Site Assessment: TRI Container
Catoosa, Rogers Co., Oklahoma
TDD#: T06-9311-011
PAN : EOK0419SA

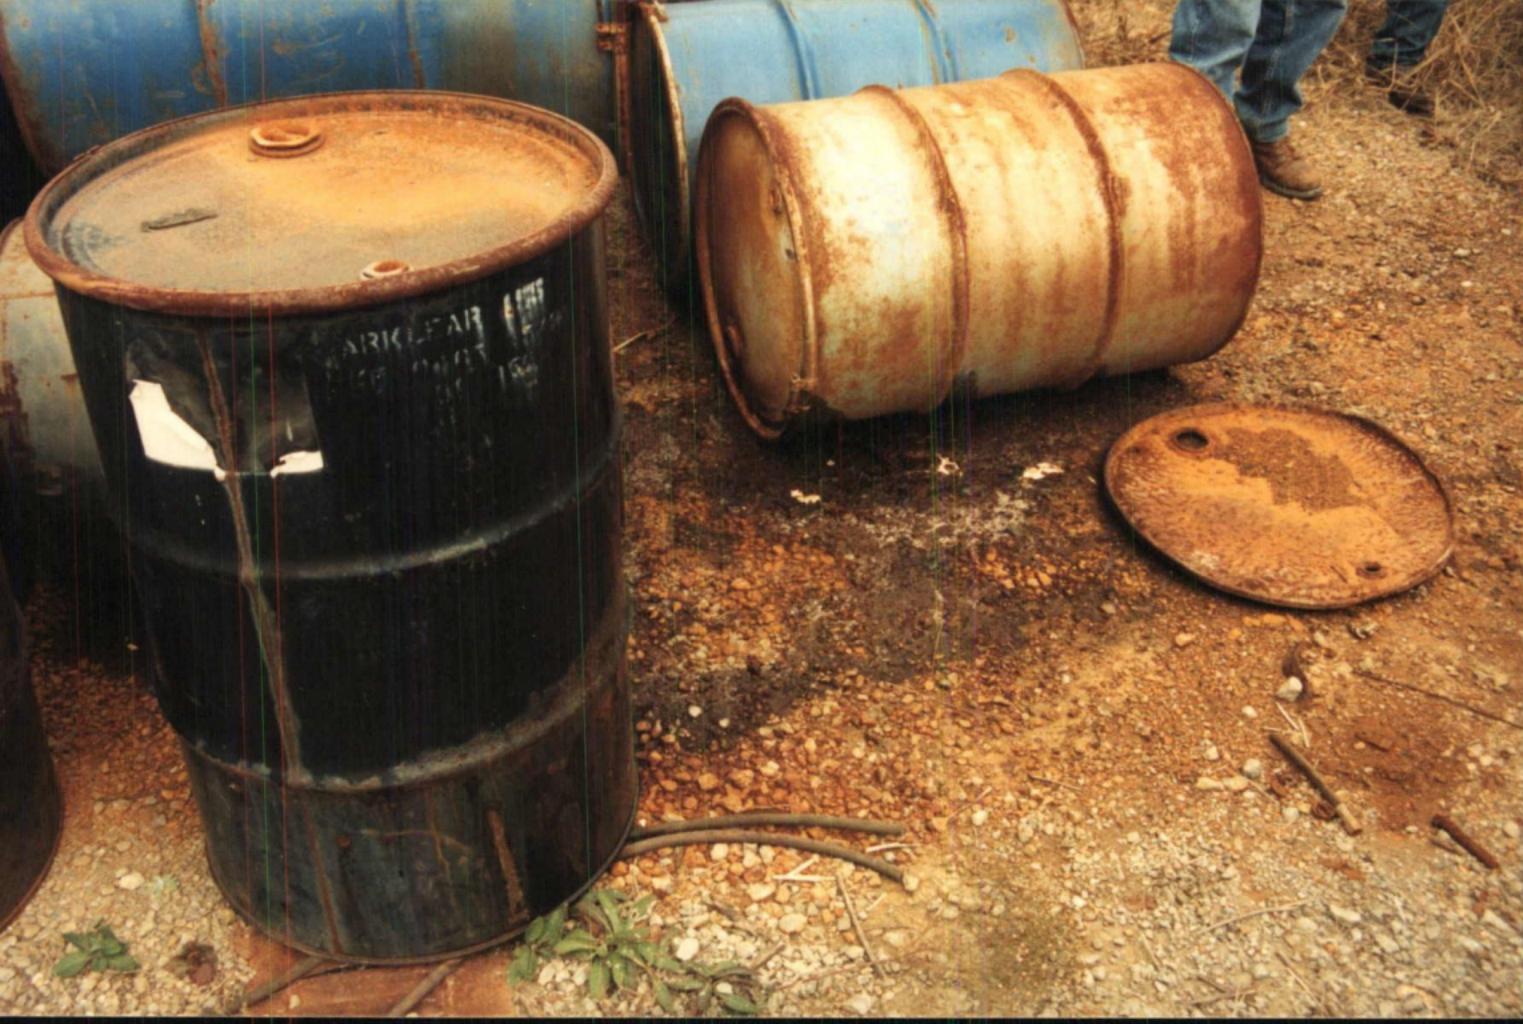
SITE NAME: TRI CONTAINER, INC. TDD#: T06-9311-011
PHOTO#: 212, PHOTOGRAPHER/WITNESS: NEELEY\LONG\BANIPAL
DATE: 11/09/93 TIME: 1145 DIRECTION: DOWN
SOIL ON GROUND STAINED FROM NEARBY PILE OF DRUMS.

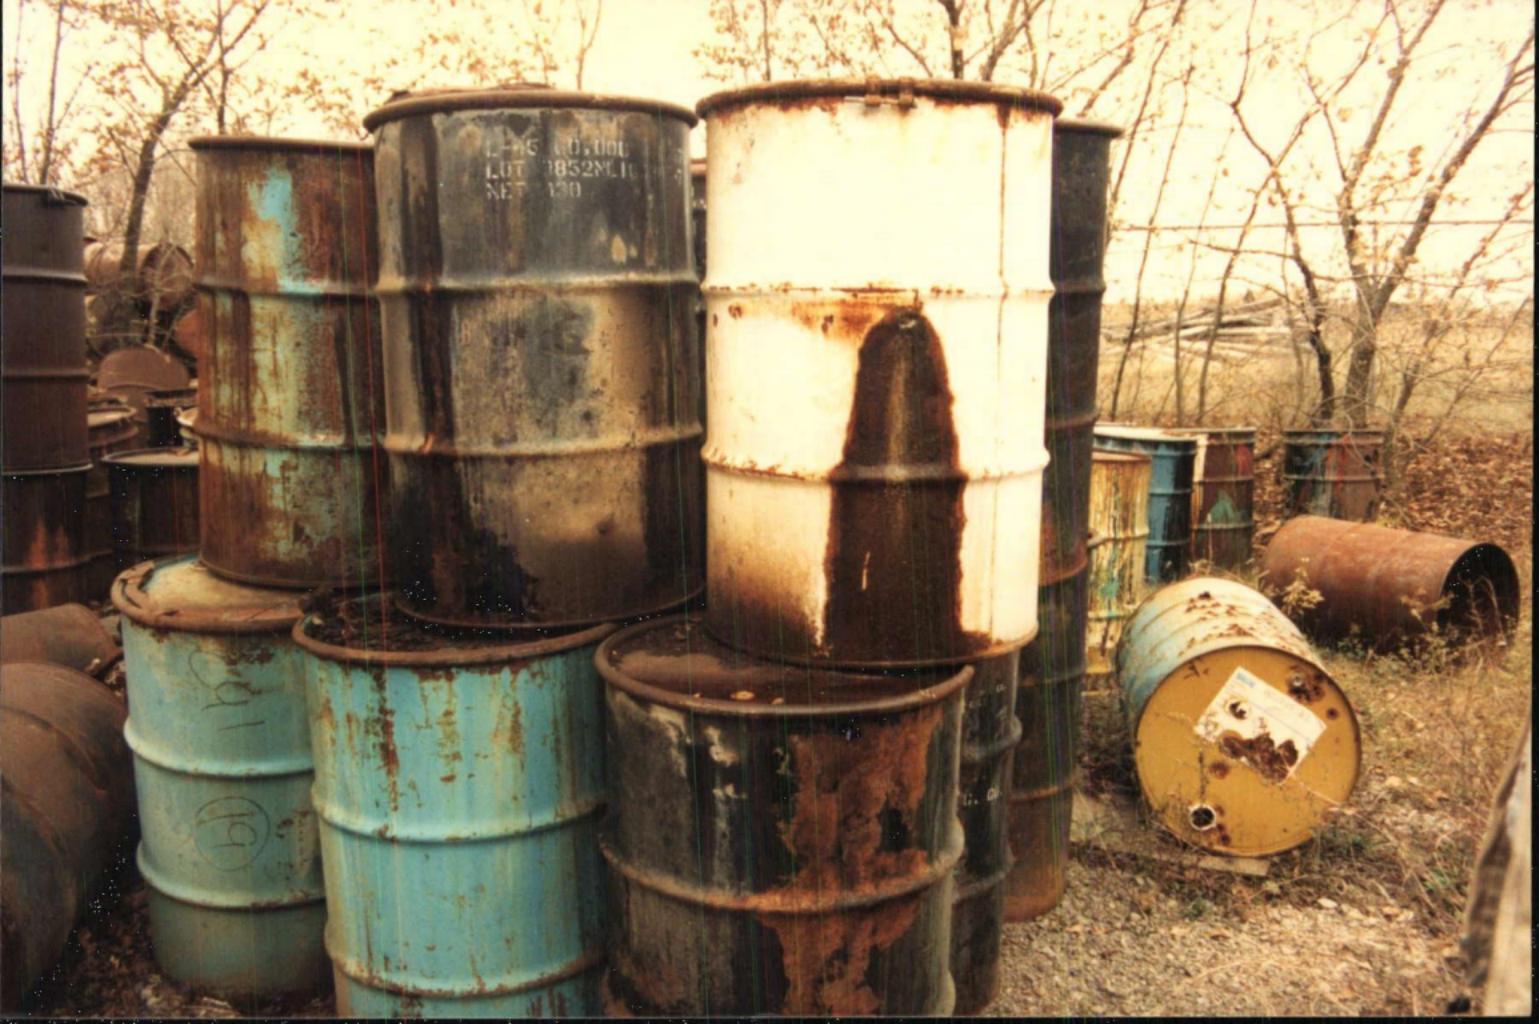
SITE NAME: TRI CONTAINER, INC. TDD#: T06-9311-011
PHOTO#: 213 PHOTOGRAPHER/WITNESS: NEELEY\LONG\BANIPAL
DATE: 11/09/93 TIME: 1150 DIRECTION: N
LEAKING DRUMS IN VARIOUS STAGES OF DETERIORATION.

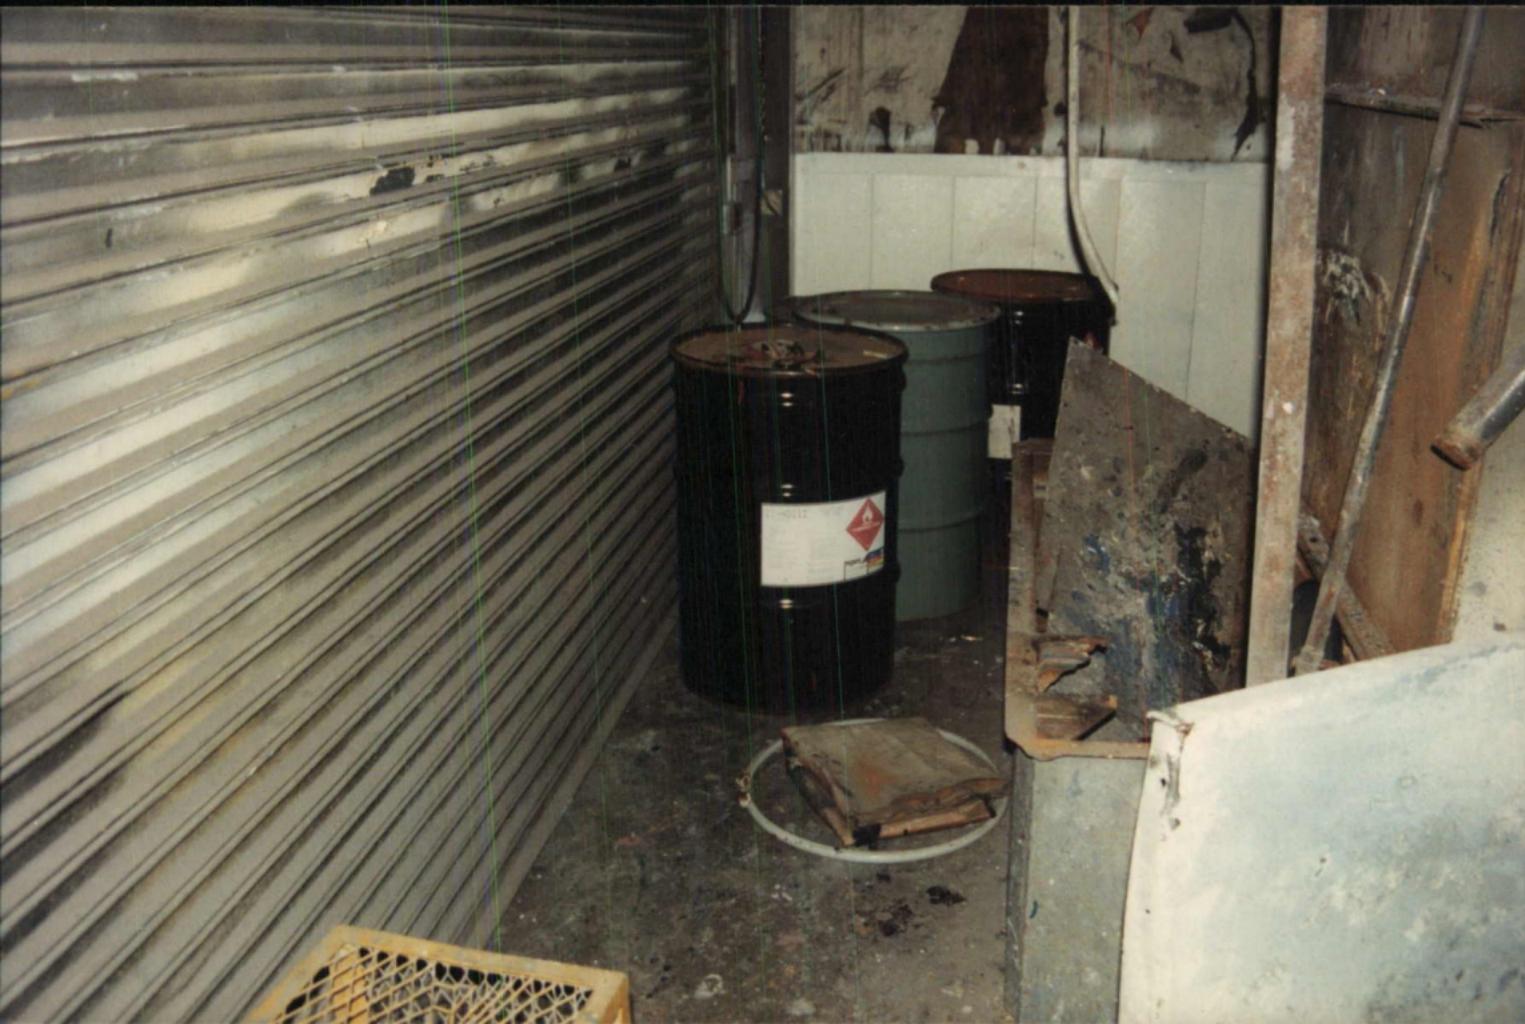
SITE NAME: TRI CONTAINER, INC. TDD#: T06-9311-011
PHOTO#: 302 PHOTOGRAPHER\WITNESS: NEELEY\LONG\BANIPAL
DATE: 11/09/93 TIME: 1205 DIRECTION:
DRUMS FULL AND LABELED "FLAMMABLE"

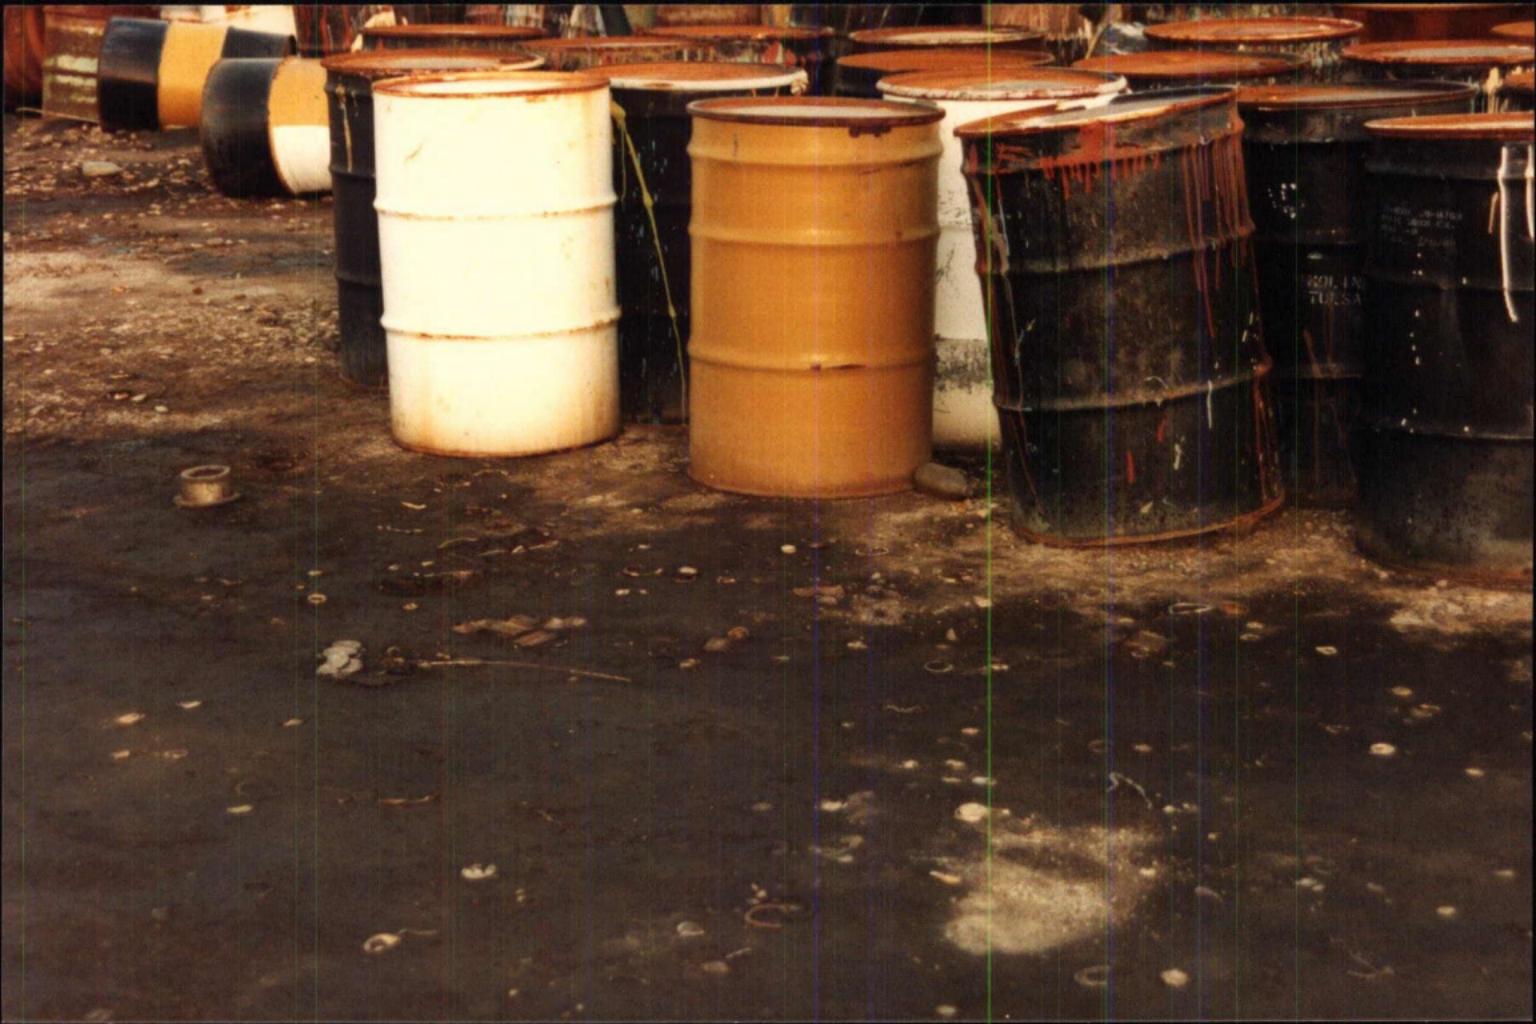
SITE NAME: TRI CONTAINER, INC. TOD#: T06-9311-011
PHOTO#: 305 PHOTOGRAPHER\WITNESS: NEELEY\LONG\BANIPAL

DRUMS STAGED ON PROPERTY CONTAINING VARIOUS AMOUNTS OF WASTE.

NOTE STAINED SOIL.

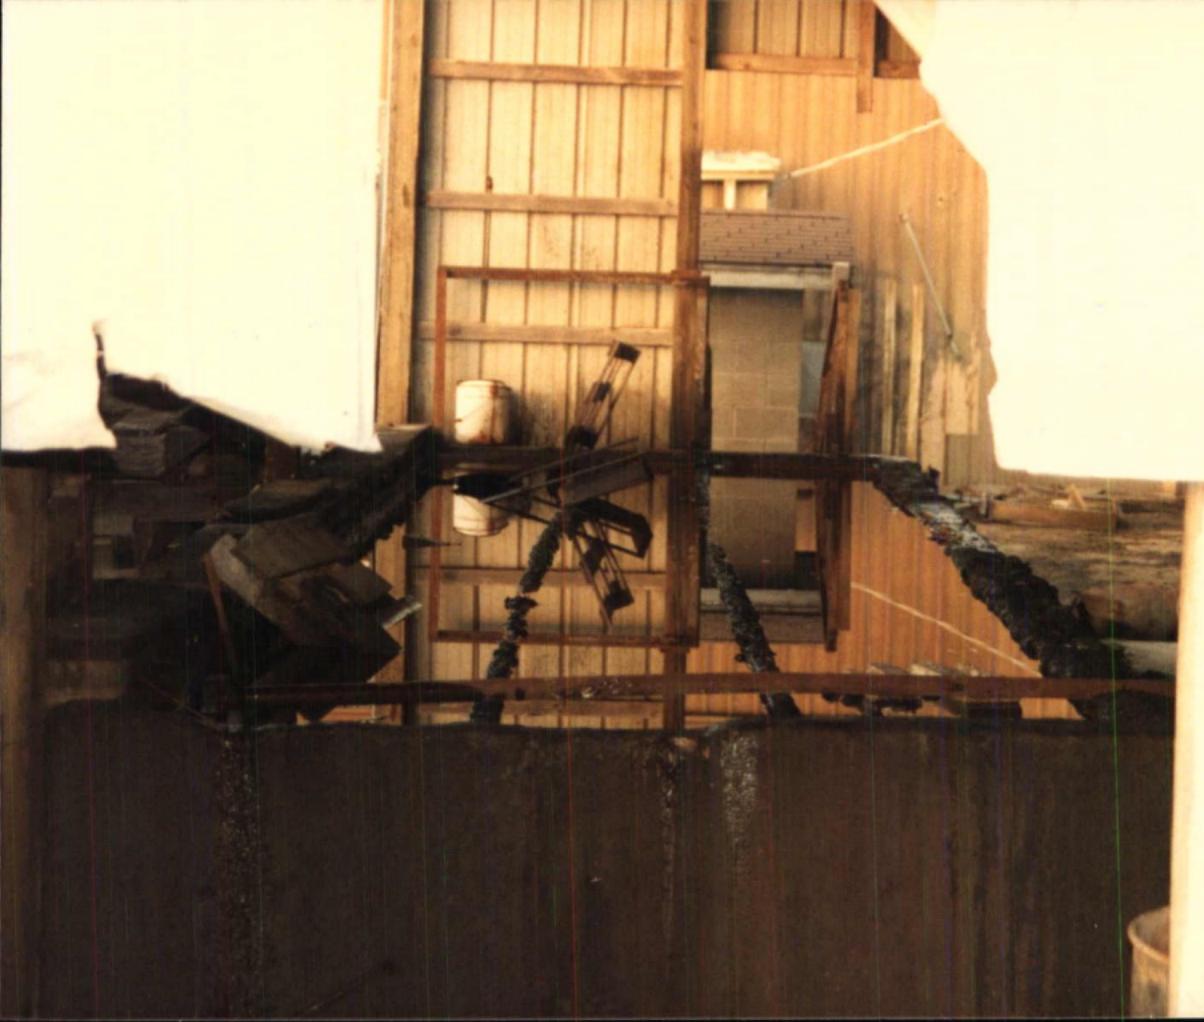
SITE NAME: TRI CONTAINER, INC. TDD#: T06-9311-011
PHOTO#: 306 PHOTOGRAPHER\WITNESS: NEELEY\LONG\BANIPAL
DATE: 11/09/93 TIME: 1705 DIRECTION: N
VAT IN DRUM WASH SHED.

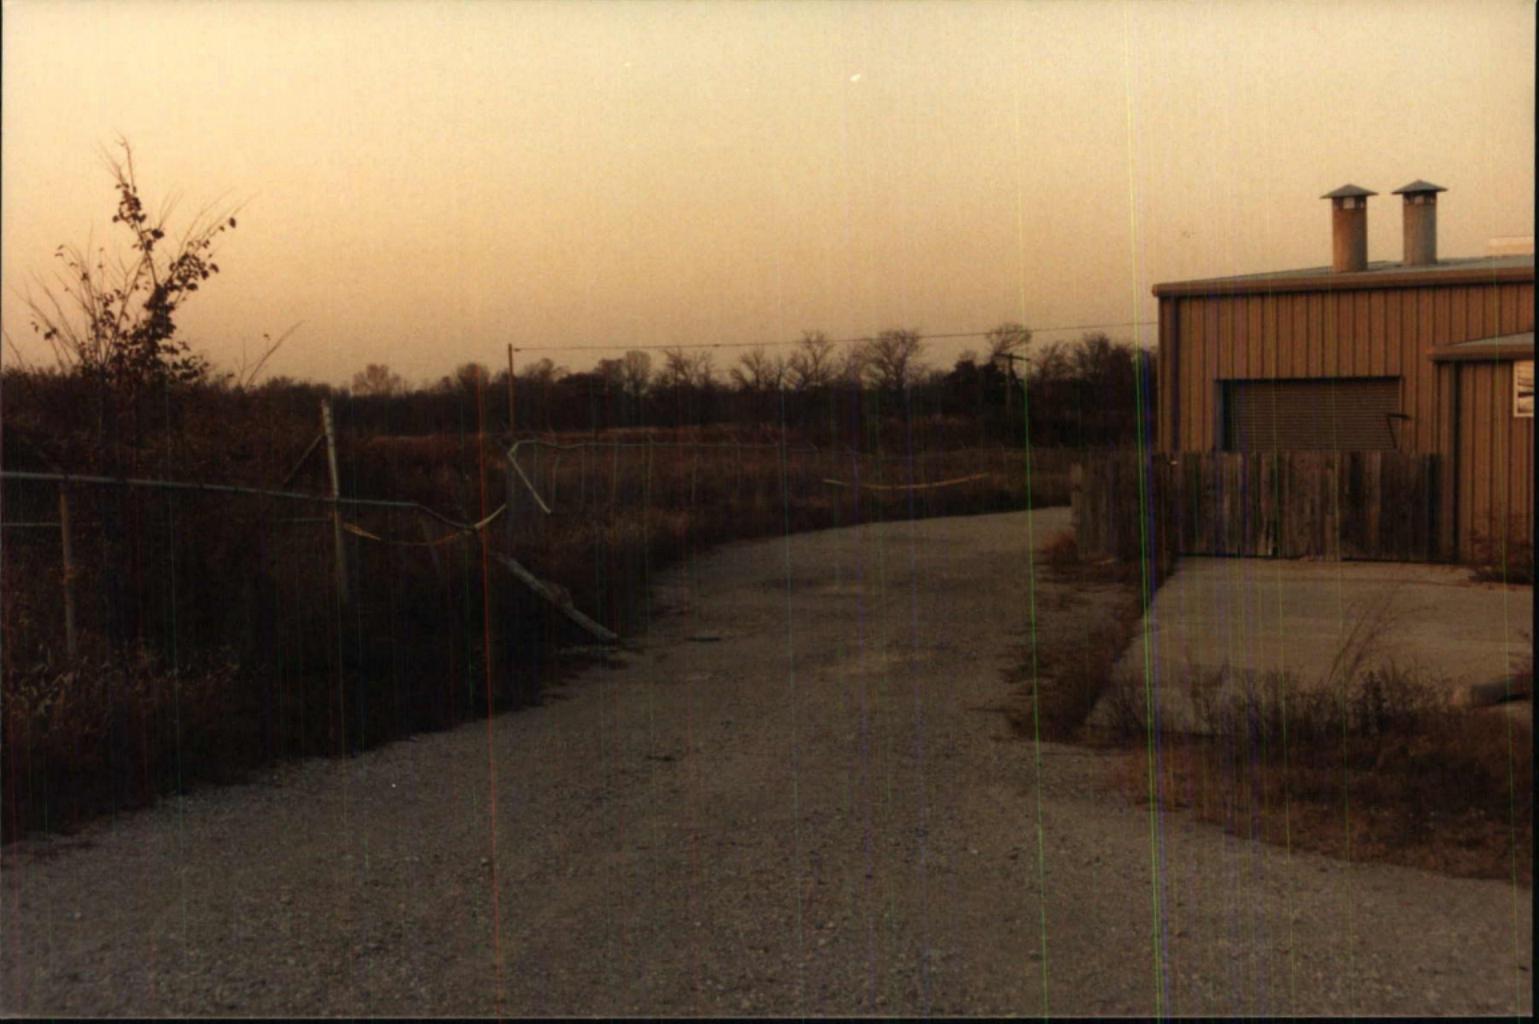
SITE NAME: TRI CONTAINER, INC. TDD#: T06-9311-011
PHOTO#: 307 PHOTOGRAPHER\WITNESS: NEELEY\LONG\BANIPAL
DATE: 11/09/93 TIME: 1710 DIRECTION: NW
FENCE NORTHWEST SIDE OF FACILITY PARTIALLY TORN DOWN.

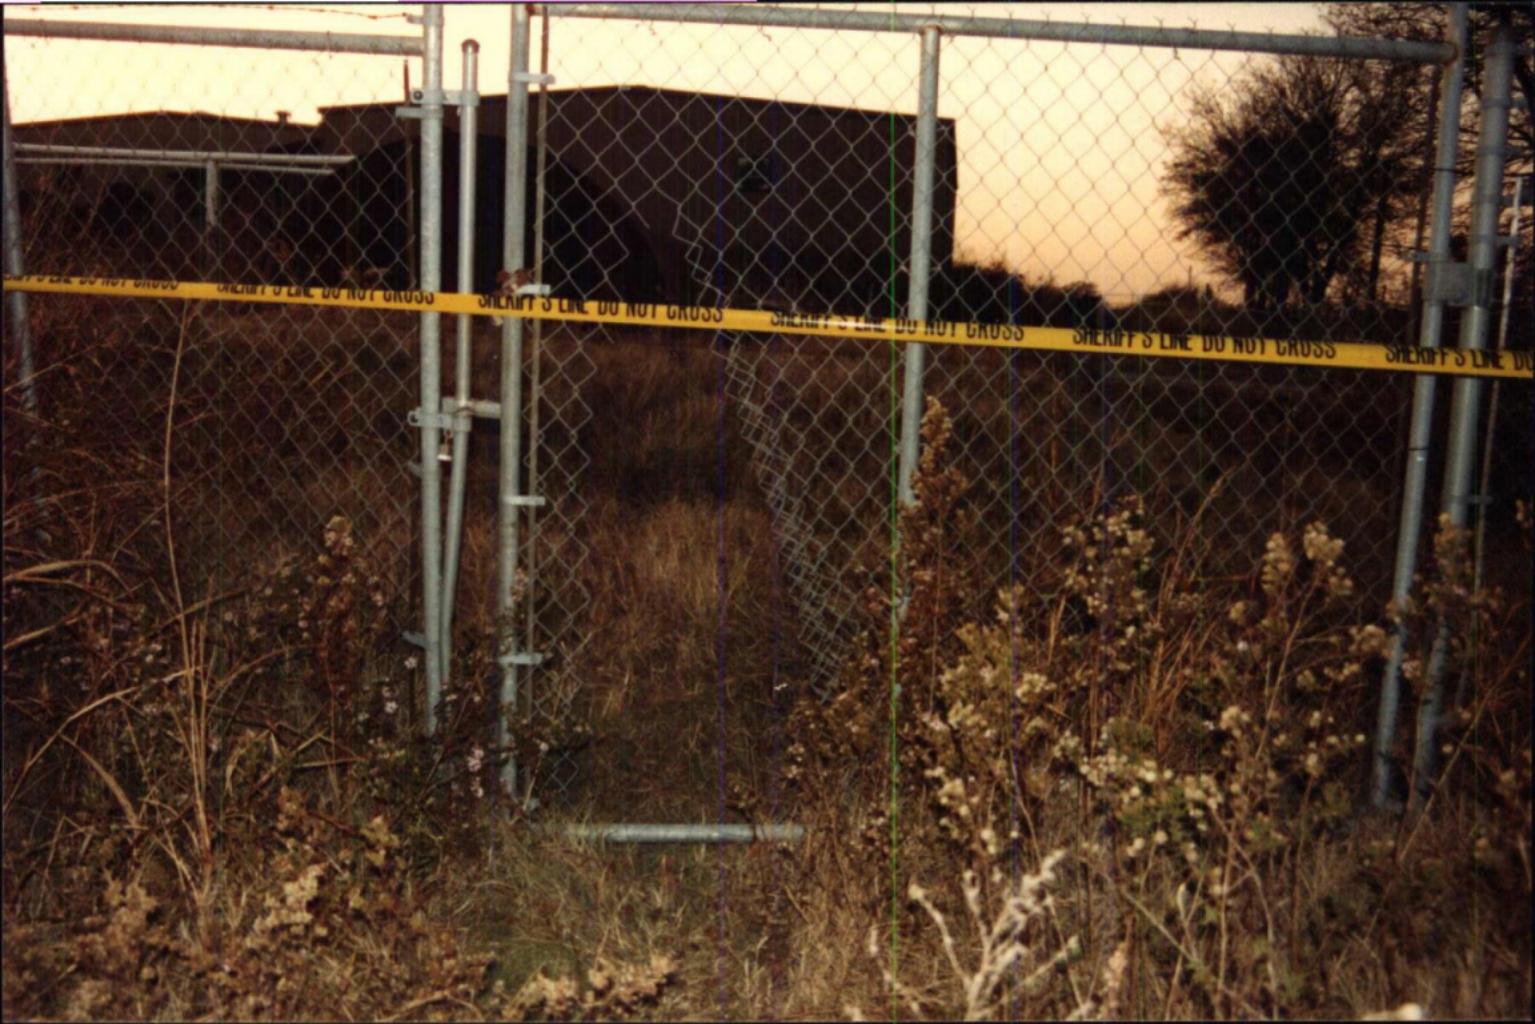
3-9

SITE NAME: TRI CONTAINER, INC. TDD#: T06-9311-011
PHOTO#: 309 PHOTOGRAPHER\WITNESS: NEELEY\LONG\BANIPAL
DATE: 11/09/93 TIME: 1712 DIRECTION: W
HOLE IN FENCE GATE AT NORTHEAST SIDE OF FACILITY.

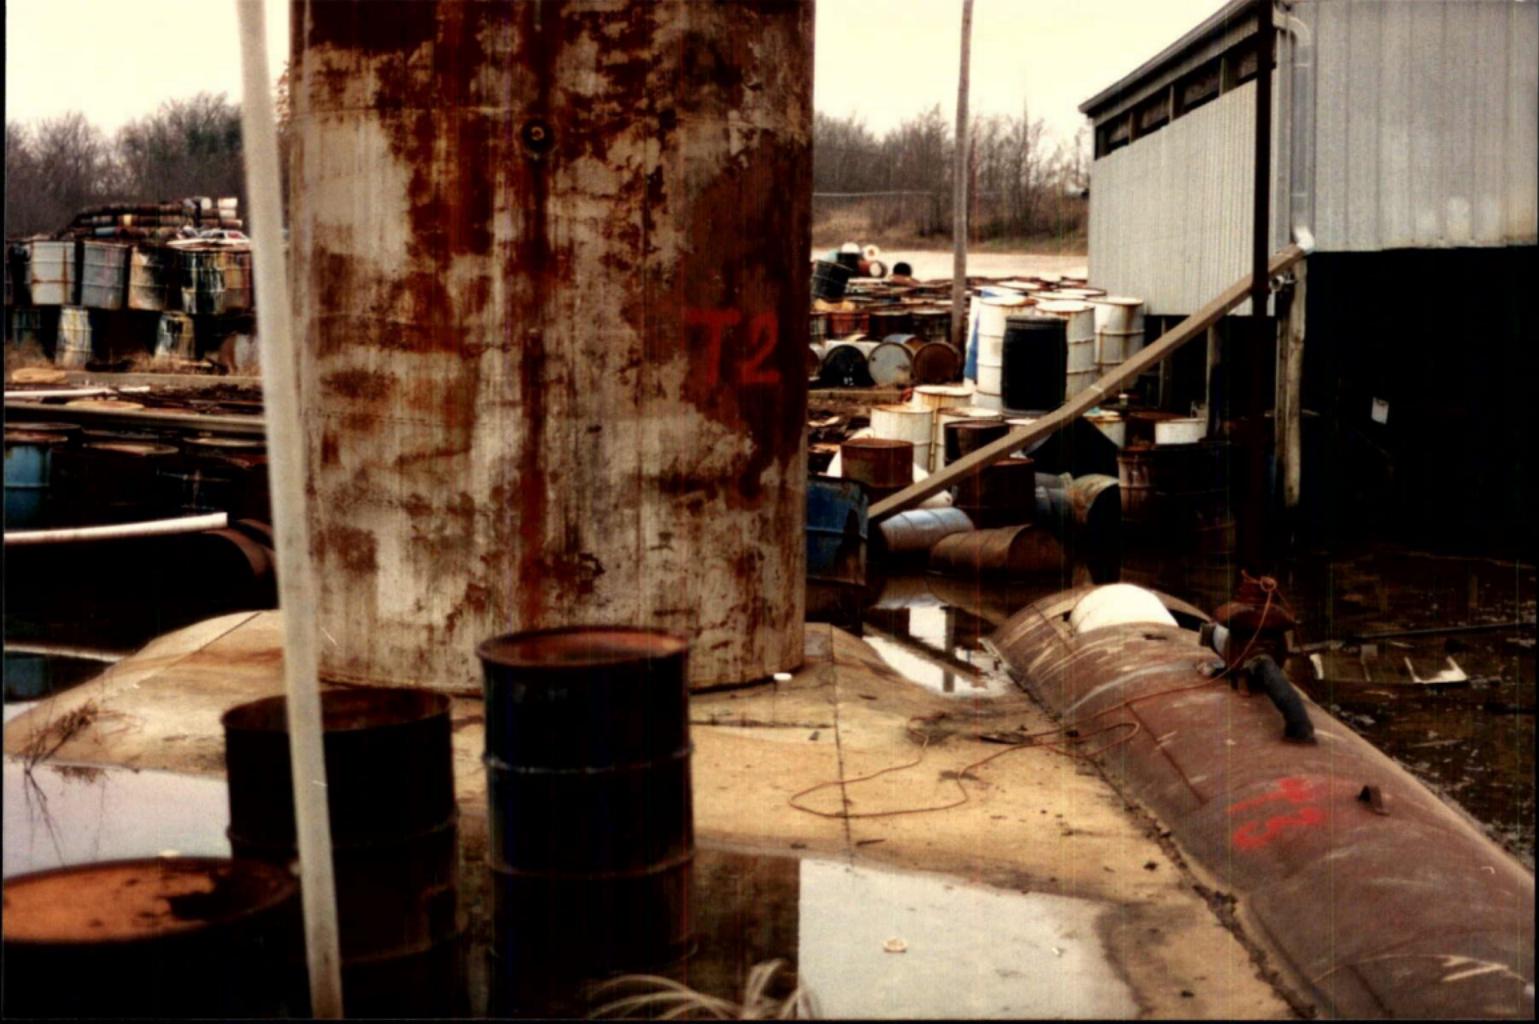
4-22

SITE NAME: TRI CONTAINER, INC. TDD#: T06-9311-011
PHOTO #: 422 PHOTOGRAPHER\WITNESS: NEELEY\LONG\BANIPAL
DATE: 11/16/93 TIME: 0907 DIRECTION: S
TANKS T-2 AND T-3 (PARTIALLY UNDERGROUND)

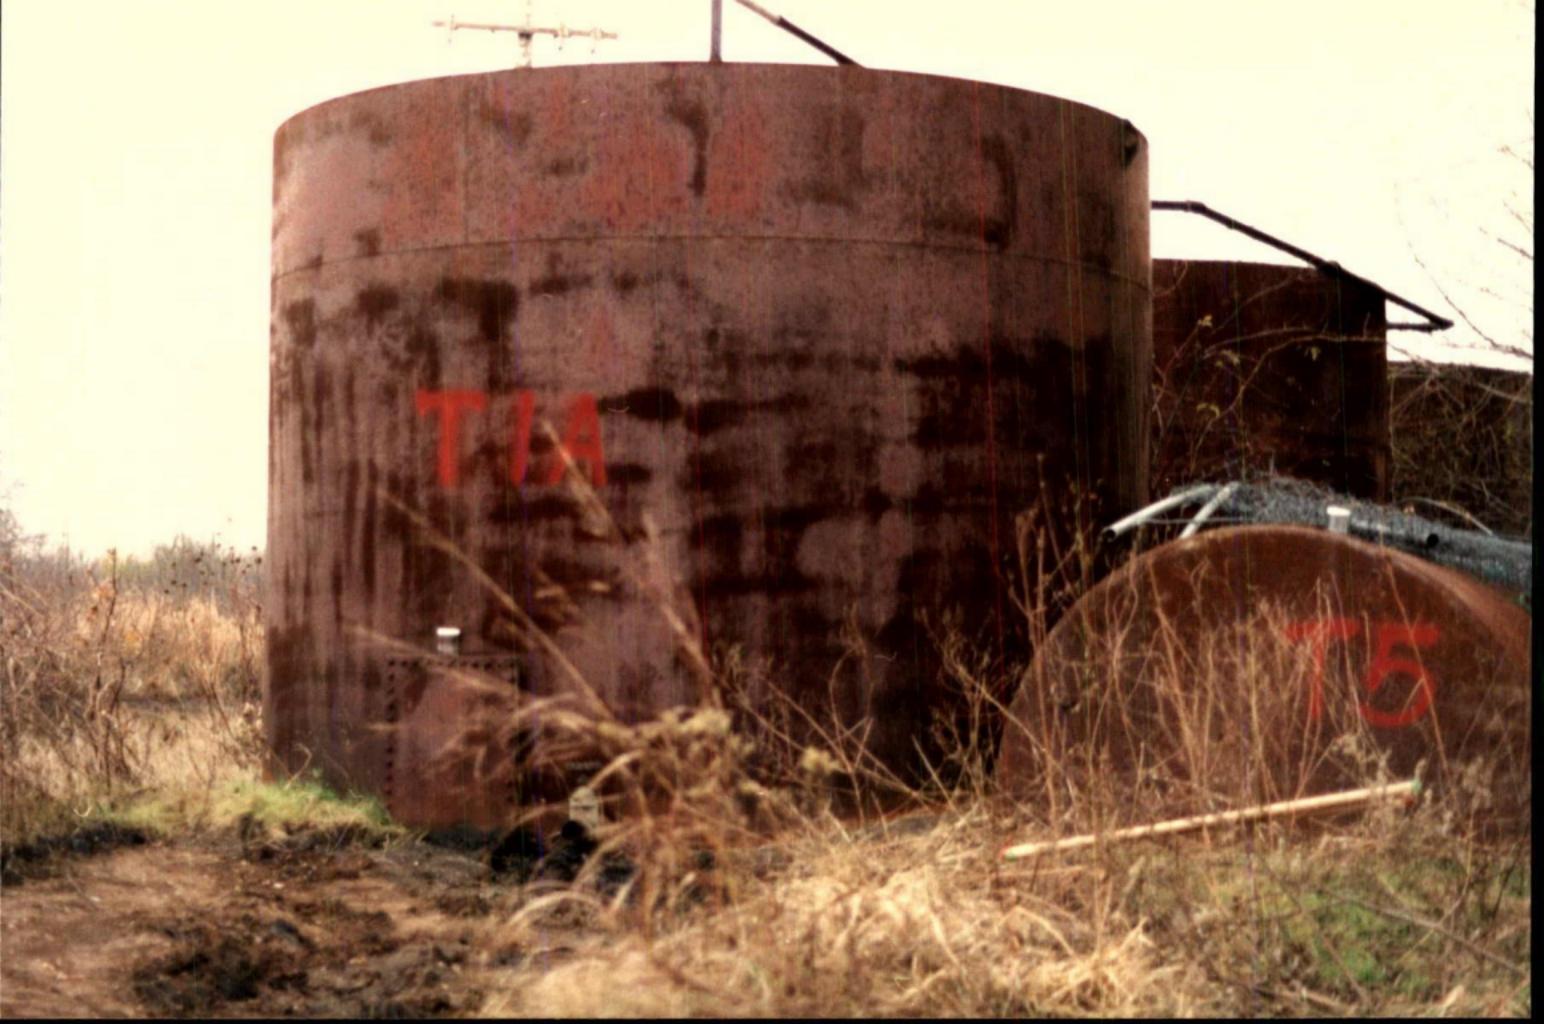
SITE NAME: TRI CONTAINER, INC. TDD#: T06-9311-011
PHOTO #: 423 PHOTOGRAPHER/WITNESS: NEELEY\LONG\BANIPAL
DATE: 11/16/93 TIME: 0920 DIRECTION: S
TANK T-1A
